CITY OF BALTIMORE WET WEATHER CONSENT DECREE SMOKE AND DYED WATER TESTING FORM		Page 1 of 4
Sewershed: Low Level Subsewershed: 42	Company: REI/DRAYCO	Date: 09/11/2008
Test Type: Smoke	Ground Condition: Dry: <input checked="" type="checkbox"/> Damp: <input type="checkbox"/> Wet: <input type="checkbox"/>	Supervisor: E.R. Crew: 04
Manhole ID: S21W__037MH	Test ID: 1029-547	Notifications Made: <input type="checkbox"/> X___ Residents, Fire, 311
Field Sketch: (Show all manholes with numbers, blower placement location, sandbag or isolation locations, street names, building addresses and locations, defect locations and photograph numbers)		
<p>The field sketch is a map of a residential area with streets and building footprints. A red line traces a path through several manholes, labeled with numbers: 029, 026, 012, 018, 023, 001, 002, and 037. A yellow line is also visible in the upper left. A blower is indicated at manhole 037. Labels with red boxes and arrows point to specific locations: '547_OB01-01' points to a location near manhole 002, 'BLOWER #1 S21W__037MH' points to manhole 037, and '547_OB02-01' points to manhole 023. Street names and building addresses are visible on the map, incl

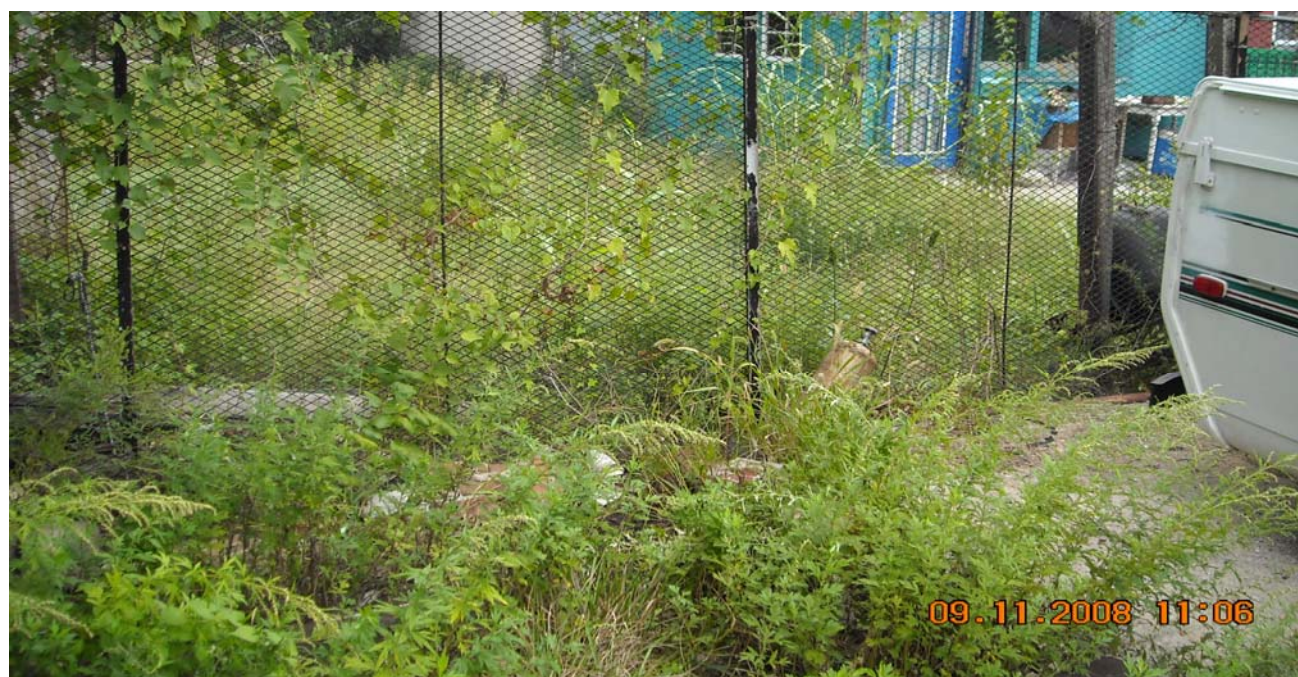
Photograph No: OB01-01
Filename: 1029-547_OB01-01.jpg

Unique Test ID: 547	Date: 09/11/2008	Basin: LL - 42	Manhole ID: S21W__037MH
Defect No: OB01	Supervisor: E.R.	Crew: 04	Dye Test Recommended: N
Location: S21W__002MH			
Source Type: 18 Other		Location: 09 Yard - Side	
Sector: 02 Private		Severity: 03 Moderate	Drainage Area: 50
Comments: THIS IS SUSPECTED LOCATION OF MANHOLE S21W__002MH. SMOKE IS COMING FROM LARGE AREA AND SUSPECT THERE MAY BE AN UNKNOWN DEFECT.

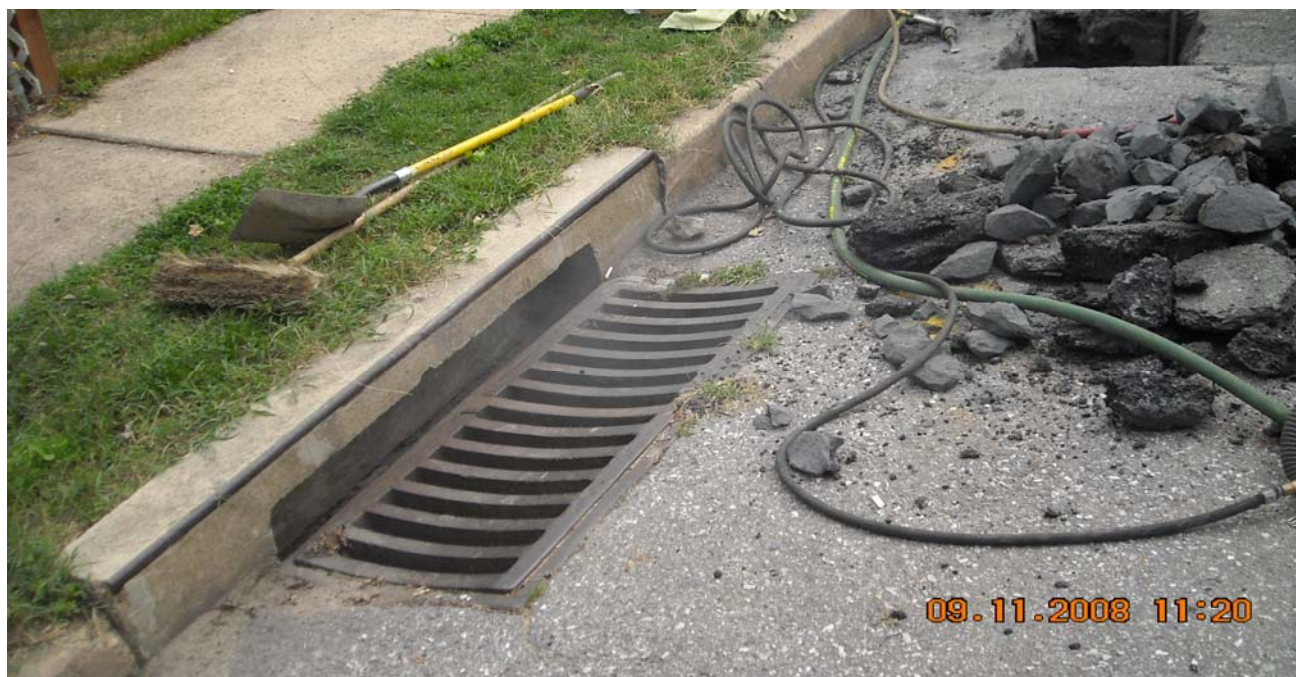
Photograph No: OB02-01
Filename: 1029-547_OB02-01.jpg

Unique Test ID: 547	Date: 09/11/2008	Basin: LL - 42	Manhole ID: S21W__037MH
Defect No: OB02	Supervisor: E.R.	Crew: 03	Dye Test Recommended: N
Location: 1921 BREITWERT AVE.			
Source Type: 12 Catch Basin		Location: 06 Curb	
Sector: 01 Public		Severity: 03 Moderate	Drainage Area: 2000
Comments: SMOKE IS COMING FROM THIS CATCH BASIN. NOTE - BALTIMORE CITY CREWS WERE WORKING ON A GAS LINE HERE.
